2022 NSW FLOOD INQUIRY SUBMISSION – June 2022

OUR STORY

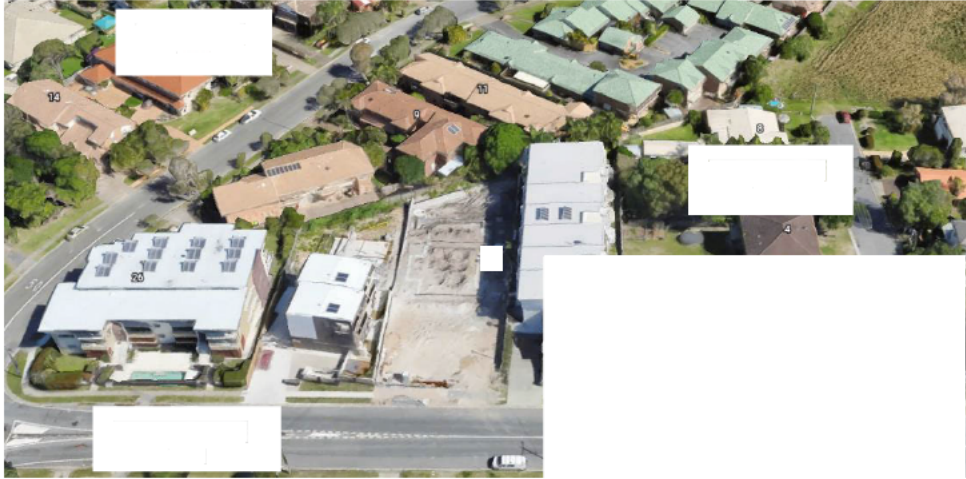
It is possible that the construction that has been approved and occurred on the adjoining blocks at [REDACTED] has changed the water course and water table. As such, there is serious concern about the impact of the planned developments which are part of the Gales Kingscliff Master Plan proposal and that they may exacerbate the water course and water table problem. As a reference point, the following is an old Google Earth image from around 2014-2015 showing the location of [REDACTED] and surrounding streets/blocks:

Image 1: Construction in surrounding streets/ blocks circa 2014-2015

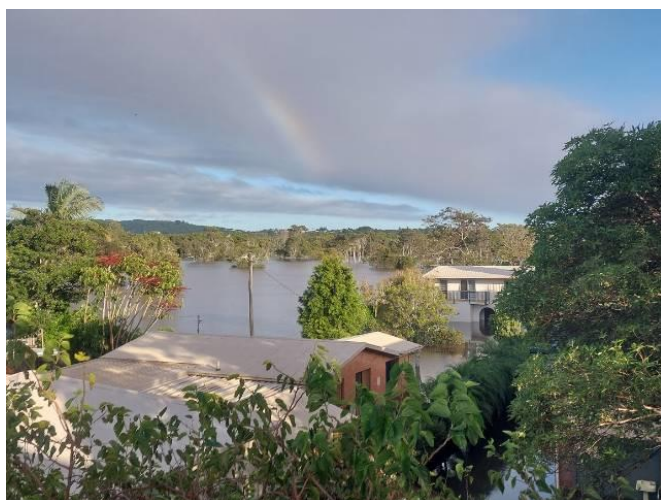
2022 – March – The flooding experienced was in the garage basement and the storage cages but was not as severe as the flooding we experienced in 2020. The waterproofing of the lift well helped to keep water out of the lift well overrun and water entering the lift well was pumped out by the submersible bilge pump. However, flood waters were experienced in the adjoining properties of [redacted] and only being held back by the common block wall shared with them and [redacted] – photos of 2022 flooding below.

Image 2: View looking to the end of [redacted] taken (2022)

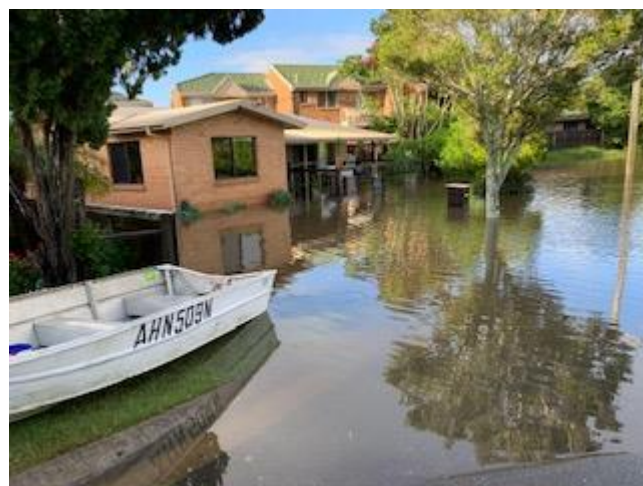
Image 3: Flood waters – [redacted] (2022)

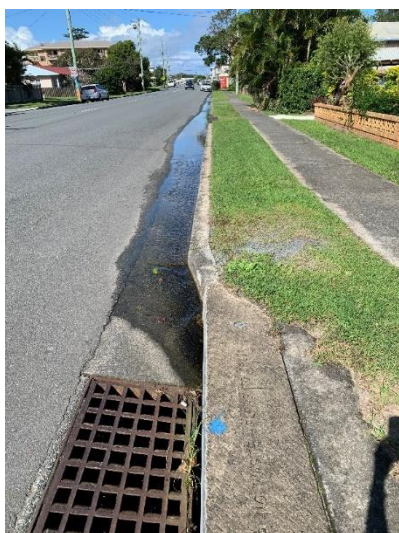
As mentioned previously, during and following periods of heavy rain, the stormwater from the stormwater pit in the basement garage can pump into the street gutter almost continuously for weeks or months and can create a green sludge/slime in some areas along the street gutter which is a safety hazard.

Image 4: Water run off to stormwater drain at [redacted] (May 2022)

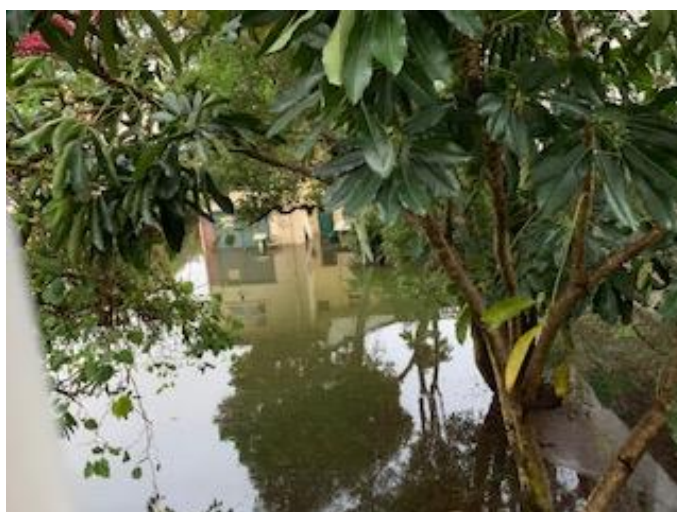
Image 5: View from balcony of unit looking to the end of [redacted] after the water had receded approx. 25cm as per water mark on wall.
