SUBMISSION TO INDEPENDENT FLOOD INQUIRY MULLUMBIMBY COMMUNITY

THIS SUBMISSION IS PRESENTED BY . Phone or
email

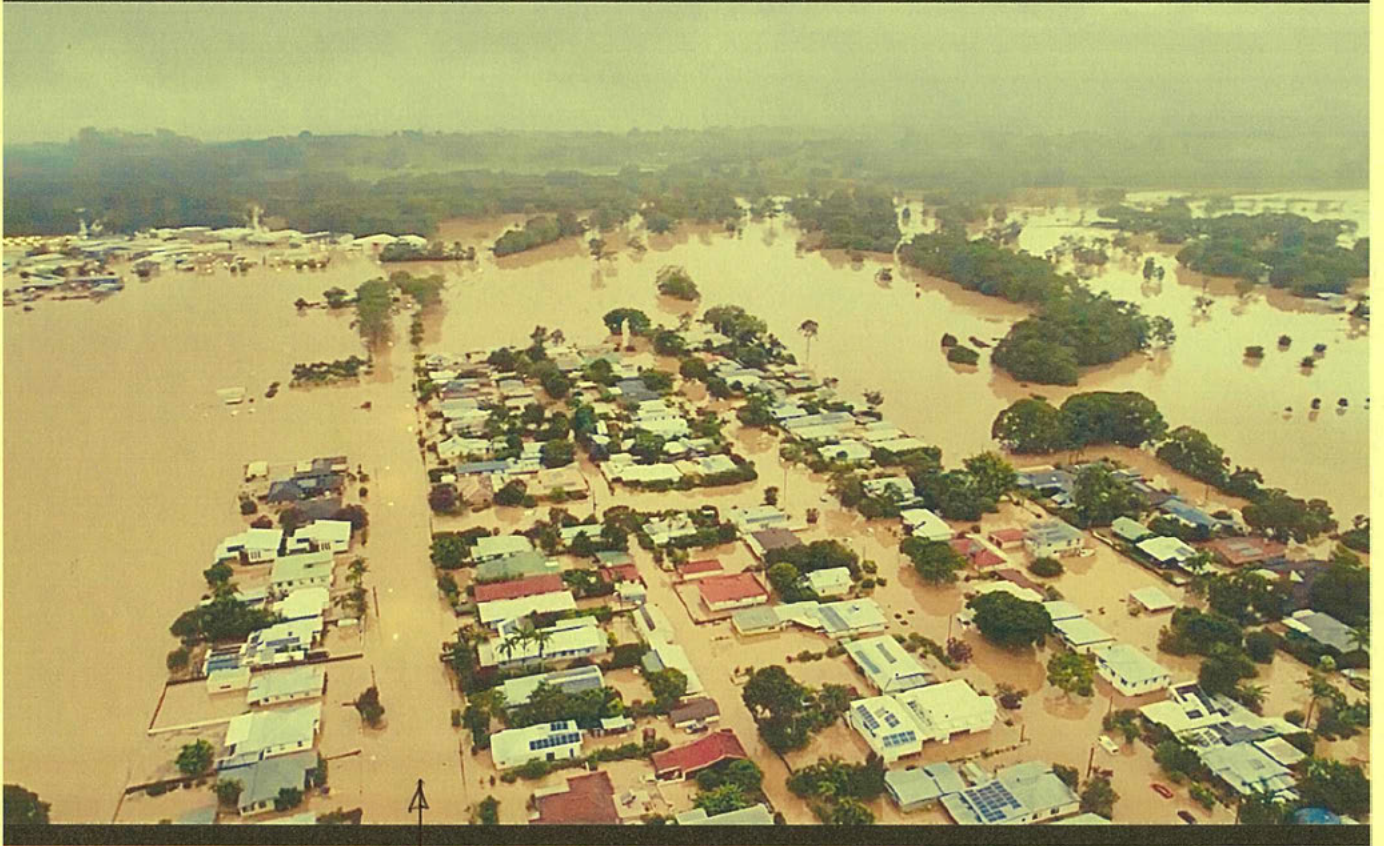
Argyle Street Mullumbimby

- Mullumbimby Floods February 28th

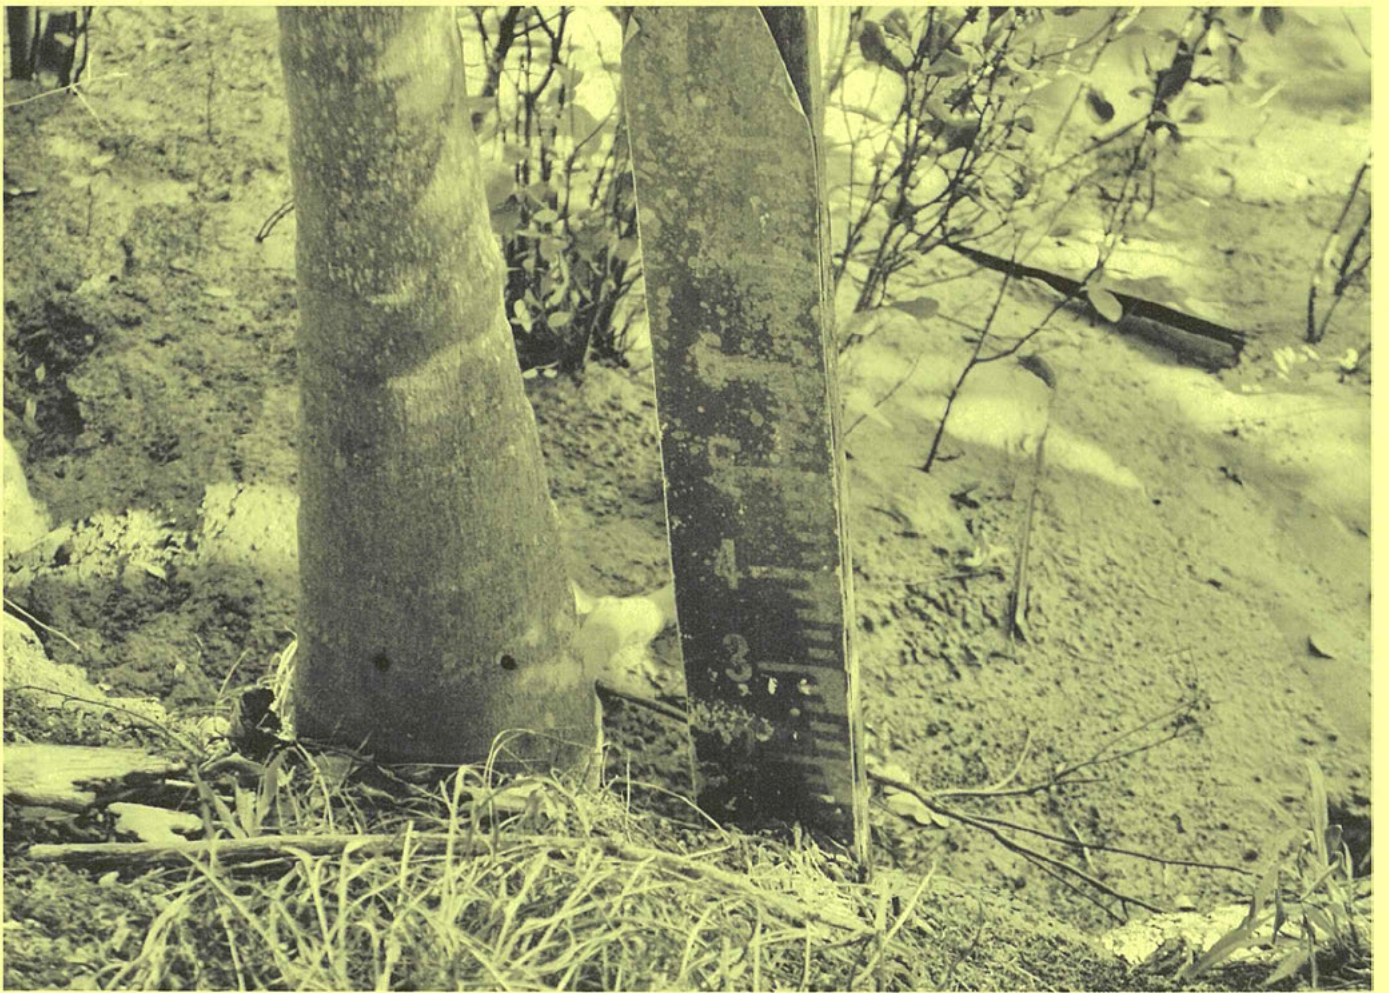
Old Visual River Gauge, 30m Up Stream
from Federation Bridge &

THE RIVER GAUGE ON THE FEDERATION BRIDGE IS ON THE DOWN STREAM SIDE OF THE BRIDGE. THE EXISTING RIVER GAUGE DOES NOT RECORD LEVELS ABOVE 5m. AT THIS LEVEL THE BRIDGE BECOMES A DAM. I AM IN POSSESSION OF A COPY FLOOD LEVEL GRAPH ON 28/2/22 AND SHOWED A MAX HEIGHT OF 5m RECORDED. IT SHOULD BE NOTED THAT THE OLD VISUAL GAUGE IS ON THE UP STREAM SIDE OF THE BRIDGE, PERHAPS THE OLD FELLOWS WERE A BIT GLUED UP.

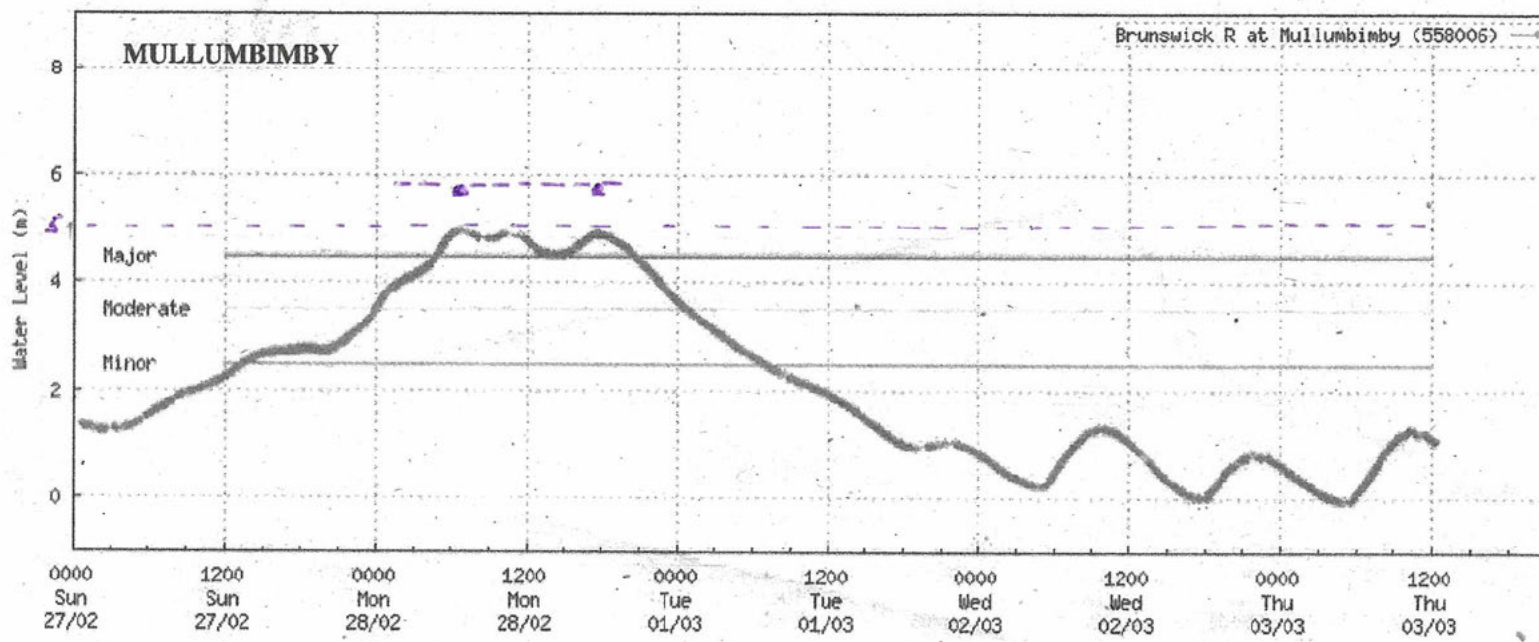
Note. 5m is the bottom of bridge superstructure.
 2017 Flood height was 600mm above superstructure on upstream side
 2022 Flood height was 550mm above superstructure on upstream side
 Prior to electronic, the flood gauge was located above the bridge and is still there.

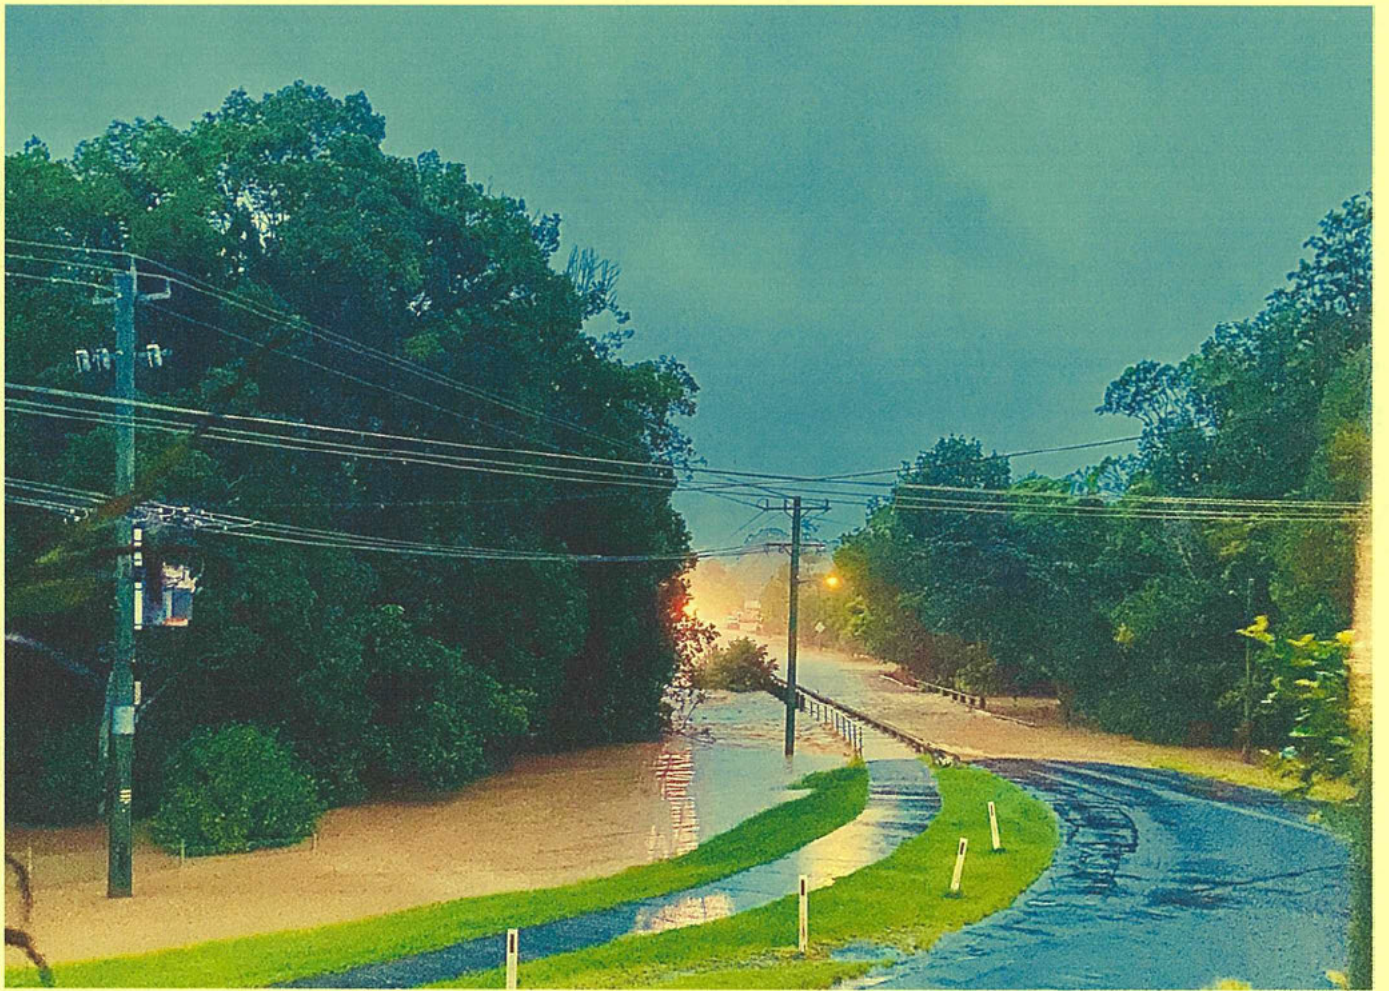
0630 hrs Water Flowing from Show Ground
down to creek at Main Arm Rd and Murvillumbah Rd
intersection

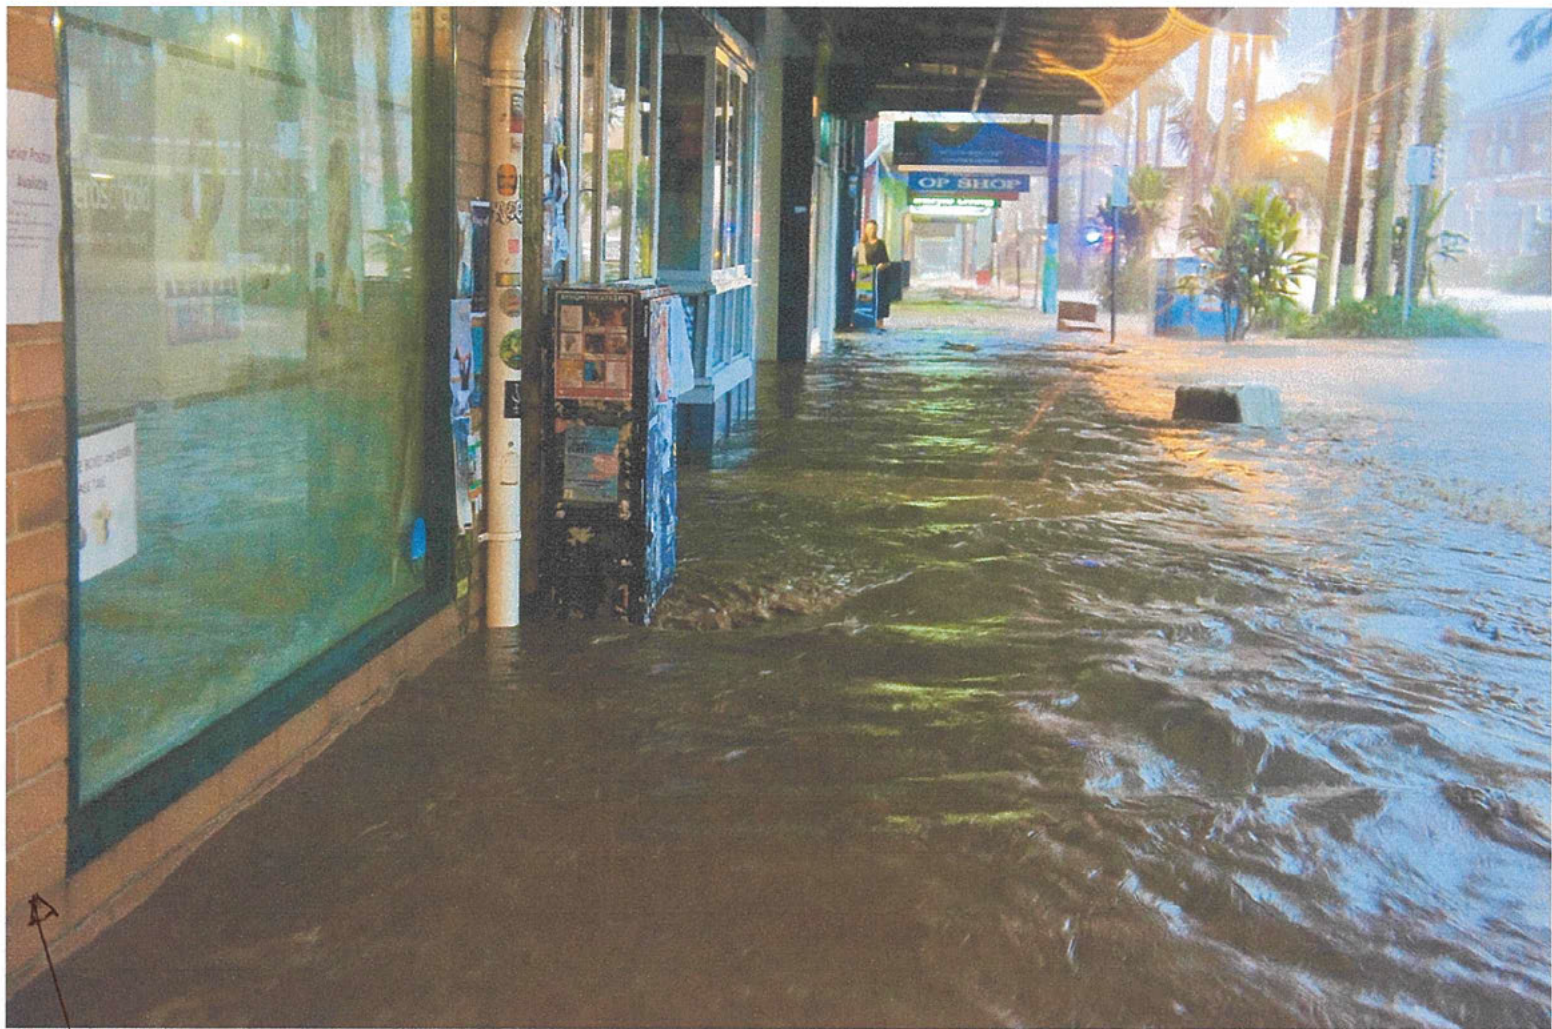
0720hrs Water flowing east down
Burringbah St

Note Wet brick Line

Water flowing Nth down
Daley St.
@ 7:22 hrs
