Your details

Title	Dr
First name	Jerry
Last name	Vanclay
Email	
Postcode	2480

Submission to the 2022 NSW Flood Inquiry

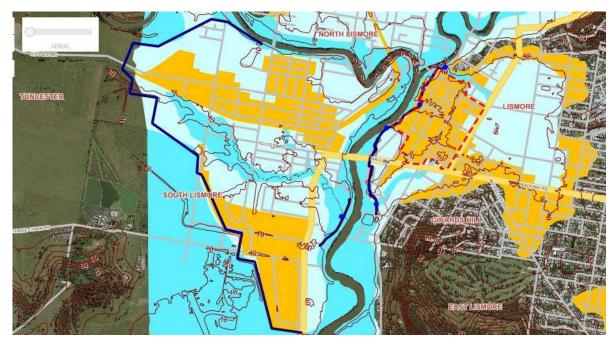
Figure 3. The Lismore CBD (red dashes) is protected by a levee (dark blue line) and pumps (blue dots) along the east bank of Wilsons River (brown). A second longer levee protects South Lismore. Floodways are shown in sky blue; vulnerable areas shown in pale blue, and areas considered 'flood fringe' are shown in orange (Lismore GIS⁴).

Despite this evidence of a choke point, construction of a levee proceeded in 2005 (Figure 3), and served the CBD well for 12 years before overtopping in 2017, and failing twice earlier this year. Subsequent assessments of flood risk (especially those areas coloured orange and denoted 'flood fringe' in Figure 3) rely largely on the assumption that the levee is failsafe (Figure 3).

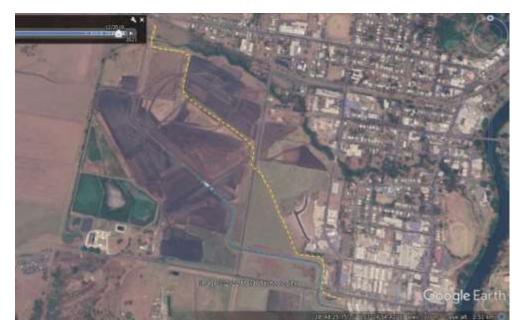
Figure 4. Earthworks (brown) nearing completion near the South Lismore sewerage plant (green), after moving 410,000m³ of soil from the floodplain outside the levee to a development site inside the levee (levee shown as dashed yellow line), and intended to direct water via a zig-zag drain (dashed blue line) into the river below Lismore (bottom right of image).

Additional engineering works were constructed following the 2017 flood⁵. The plan was to modify an existing floodway to the west of South Lismore (Figure 4) to divert water from Leycester Creek, with the

modest goal of reducing the peak of a major flood (of 12.38m, the 1% Annual Exceedance Probability AEP) by just 0.1m. This project claimed to be a \$4.3m⁶ or \$8.2m⁷ outlay, and was completed in 2019 - but it is unclear whether it has been effective or whether it achieved its objectives during the 2022 floods (Figure 5).

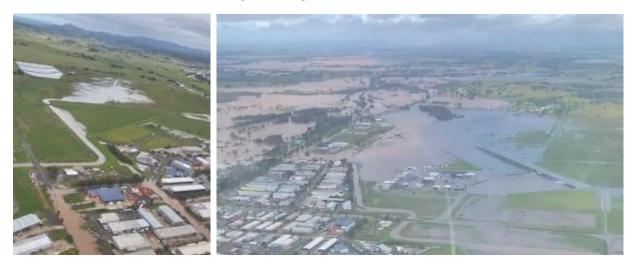
Figure 5: Photos by Rotorwing Helicopter Services⁸ showing two views of these engineering works: (**left**, 10am 31-3-22) looking northwest across the completed earthworks (top centre), with the sewerage works top left, Leycester Creek top right, and zig-zag drain bottom left; (**right** 30-3-22) looking south across the partially-flooded airport towards the Bruxner Highway, showing the zig-zag drain filled to capacity with nowhere to flow.

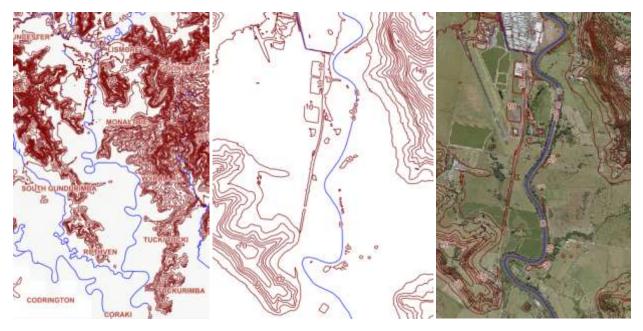
Figure 14. Images from the Lismore GIS: (left) illustrating the width of the river floodplain upstream of Coraki (with 10m contours indicated); (middle) showing detail of the section from Bunnings (Three Chain Road) to Sandy Point Road, with the Bruxner Highway and industrial estates evident above the 10m contour; (right) the same image, with aerial photography for context.

For the most part, the floodplain below Lismore is wide and flat, allowing room for floods to disperse, however, some potential choke points are evident in Figure 14 (left, from Lismore GIS, with 10m contours). The floodplain south of Bunnings (Three Chain Road) has several structures above 10m that impede floodwaters – a natural levee on the east bank opposite the recent 'Masters' excavation (below, top centre of middle image); the Bruxner Highway embankment; and several mounds in the vicinity of Sandy Point Road (bottom centre of the middle and rightmost images).

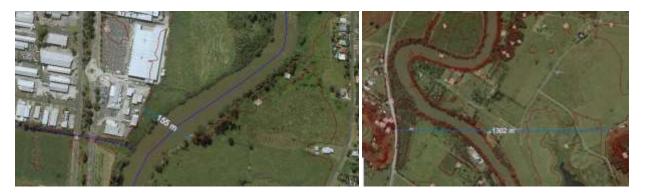
Figure 15. Stream widths at the 10m contour for two choke points below Lismore, (left) 155m just south of the Masters/Spotlight roundabout, and (right) 1300m at Sandy Point with numerous obstructions.

In particular, the river channel just below Bunnings is only 155m wide at 10m elevation (Figure 15), despite the recent 'Masters' excavations (to improve a floodway to the west of the main channel) and the modification to the zig-zag canal (just south of this point; bottom left of Figure 15 left). Further south, at Sandy Point, the channel is 1300m wide at 10m elevation but is obstructed by numerous mounds higher than 10m (Figure 15 right). These restrictions are likely to contribute to the slow drainage of floodwater from Lismore.
