From: [NSW Government](#)
To: [Flood Inquiry](#)
Subject: Floods Inquiry
Date: Wednesday, 18 May 2022 8:02:14 AM
Attachments: [Post 2022 Flood.PNG](#)
[June 2004.PNG](#)

Your story	Our house has been here since the 1890s. Up until the construction of Sherrys Bridge around 1966 the lower river-side paddock, which is floodplain, had remained largely unchanged with cattle grazing freely from the house to the paddock across the old Main Arm Road (which used to be at the level of the floodplain).
-------------------	---

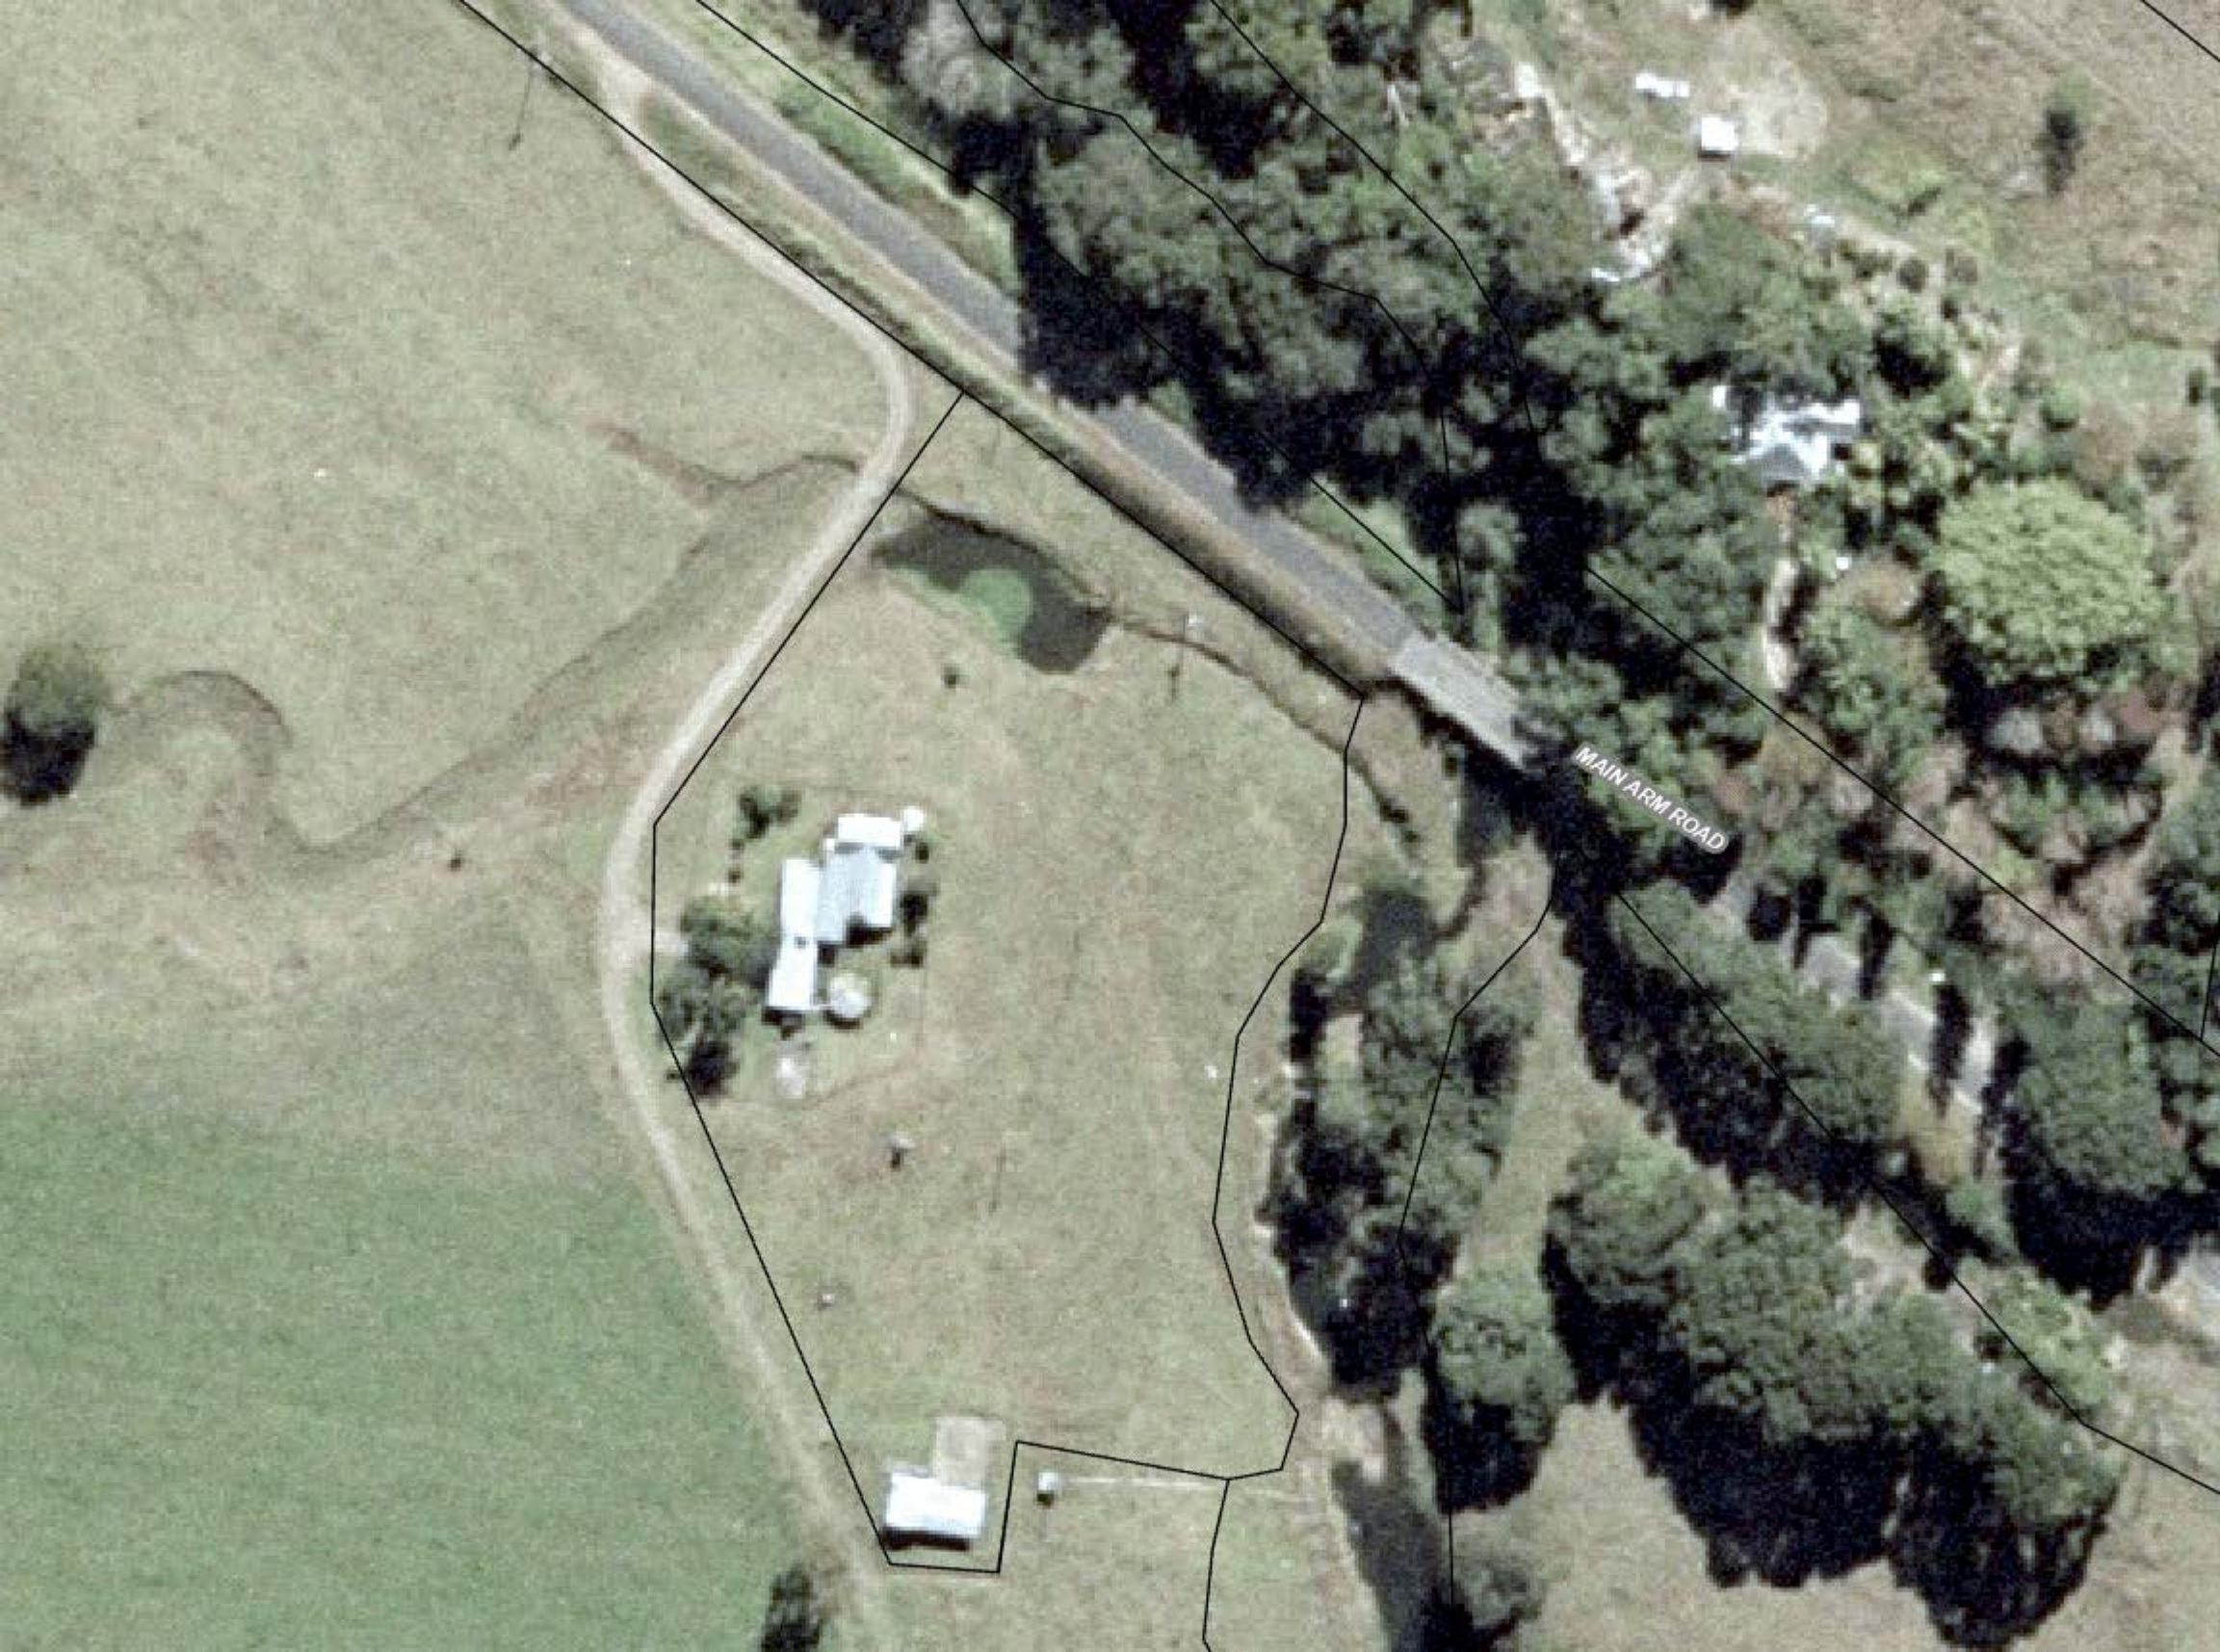
MAIN ARM ROAD

The construction of Sherrys Bridge in the 1960s involved the building up of a road embankment that effectively half dammed the flood plain and, as is obvious from the photographs, fundamentally changed the flow of flood water. It is this short-sighted intervention that shows a poor understanding of flood hydrology that has caused such extensive erosion on the river bank and our property and now presents an immediate danger to Main Arm Road.

During floods the major volume of water flow has been redirected by the road embankment to flow between our house and Main Arm Road. The flow is fast and turbulent and has been causing severe erosion with increasing velocity as the eroded chasm gets deeper and larger. The most recent flood ripped out two power poles and several large mature trees. We have lost ~1000m² of land despite my best attempts at stabilisation work over the past several years, hundreds of hours of regen work and hundreds of trees planted.

Until stabilisation works Main Arm Road and our house yard are in imminent danger of further erosion and slippage into the steep walled chasm. The deep chasm (~10m deep from road level) which is half-filled with water presents an immediate danger to vehicles travelling along this unbarricaded section of Main Arm Road.

Stabilising the land to prevent further destruction of land and infrastructure would require major engineering works to allow the river to flow along its original course.
