TELSTRA CORPORATION LIMITED

Submission to the:

2022 NSW Flood Inquiry

6 May 2022

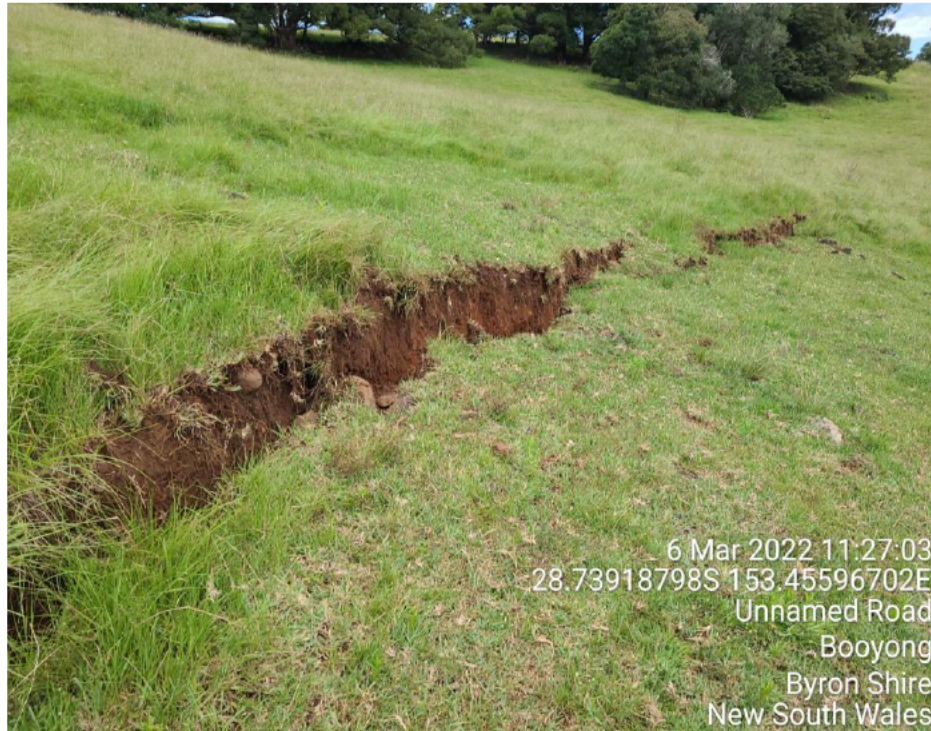
Flood related damage can be very difficult to locate. Land needs to only slide or shift a few tens of centimetres to damage optic fibres and locating the site of the land slip can be very challenging along a route that can be several kilometres long, as per Figure 1 below.¹

Figure 1: Land slip in Booyong NSW that damaged an optic fibre cable.

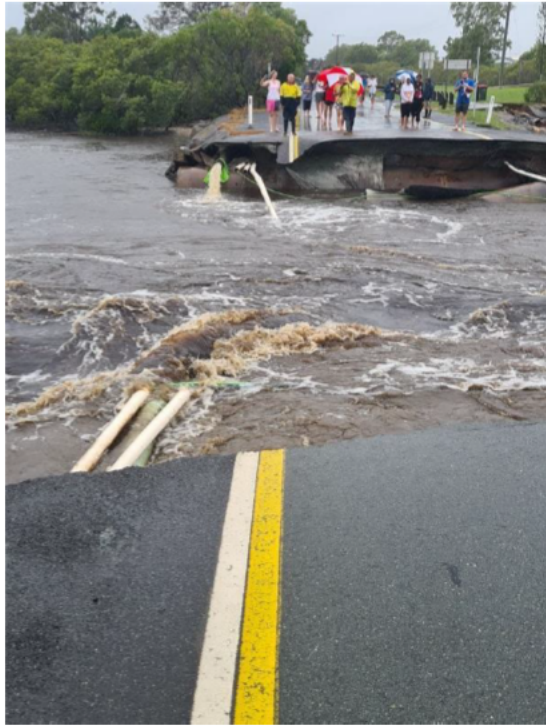
Figures 3 and 4 below show damage to an optic fibre cable and its conduit and the extent of damage caused to one of our mobile network facilities caused by the flood.

Figure 3: damaged fibre duct alongside a washed-out bridge, NSW/Qld border region

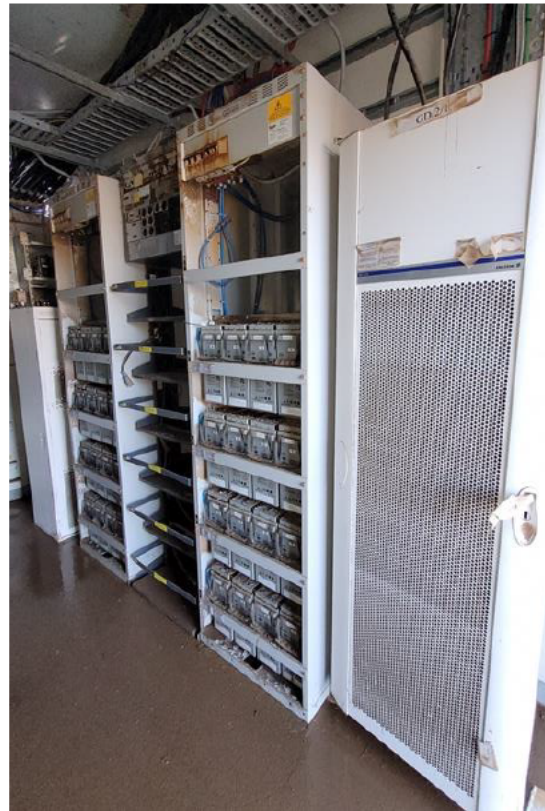
Figure 4: Flood-damaged mobile network equipment at Buckendoon (near Woodburn) in North-east NSW (See Case Study 2 below)

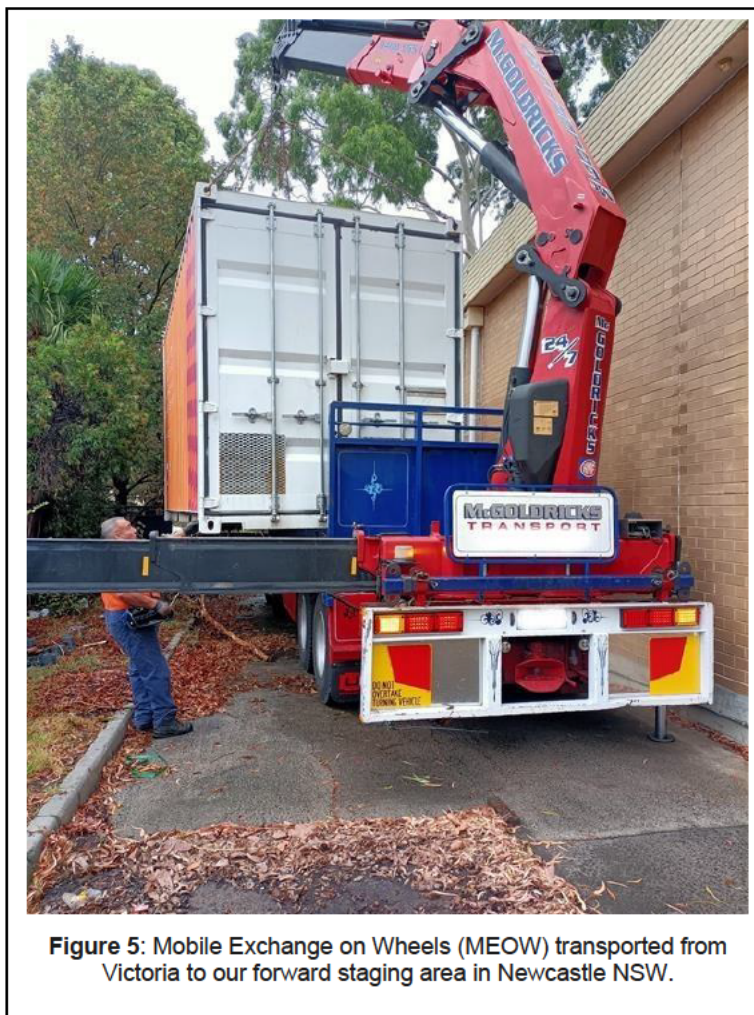
Figure 5: Mobile Exchange on Wheels (MEOW) transported from Victoria to our forward staging area in Newcastle NSW.

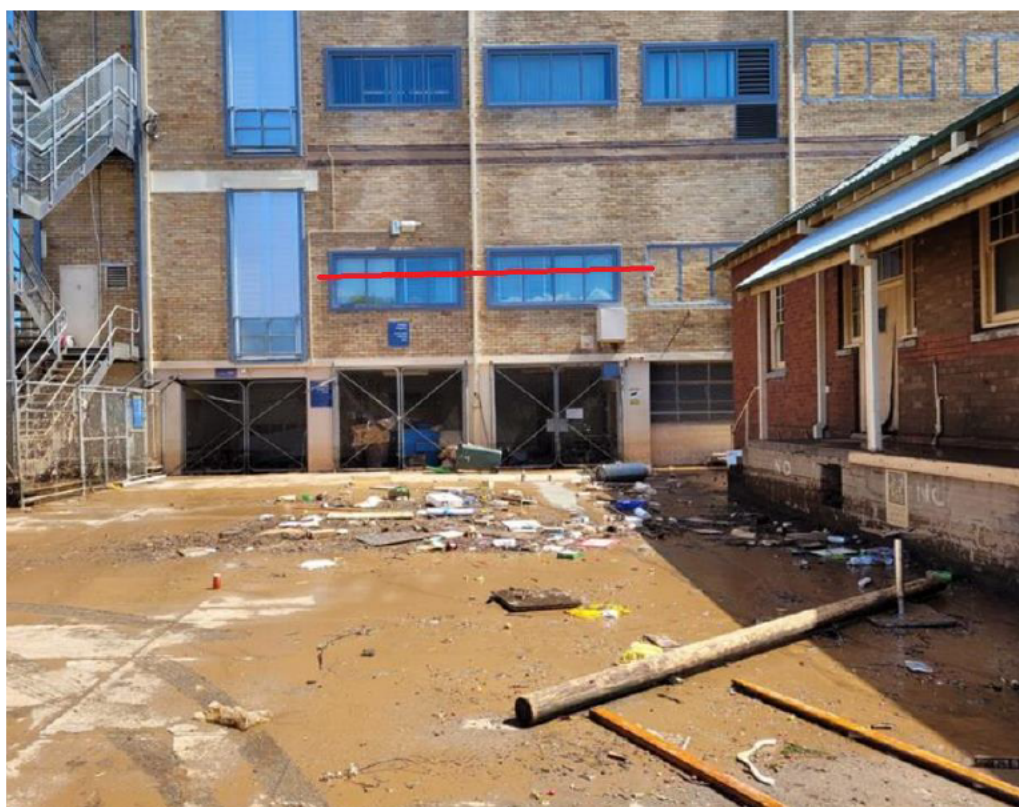
Flood levels at Lismore peaked at 14.5m; the levy is only 10m. This significantly impacted the Telstra Lismore Exchange which connects fixed line telephone, broadband and supports mobile services in the Lismore region. Telstra's Lismore exchange ground floor and half of the first floor were inundated with water – See Figure 6. This affected power and other facilities such as air-conditioning. The first floor also contained our transmission equipment linking Lismore to our wider network. Fibre washouts in the surrounding areas further affected Lismore connectivity.

Figure 6: Lismore Exchange after flood waters had receded.
The red line shows the high-water mark.

To provide some insight, the following steps are an outline of the work required to assess and then restore an exchange. All these steps were required at the Lismore exchange.

1. **Initial site assessment.** An assessment is conducted to ensure the site is safe for workers to enter the building and commence clean up. This includes assessing the building for structural hazards and carefully assessing electrical safety hazards such as on-site batteries which may still have power, if for example, a circuit-breaker cut off supply to water-logged communications equipment before the battery reserves were exhausted.

2. **Cleaning.** Initial cleaning is required to remove mud, debris and water.
3. **Environmental hazard inspection.** This is an assessment for environmental hazards such as asbestos. In the Lismore exchange, asbestos floor tiles had started to warp and curl causing potential asbestos risks by breaking underfoot and becoming friable, and environmental mitigation measures were required.

4. **Environmental mitigation.** When an environmental hazard is confirmed, a mitigation plan is developed to make the workplace safe, and the plan is implemented.

5. **Temporary power restoration.** Diesel generators are brought to site and connected to equipment and systems that have been confirmed not to have been damaged by water ingress. This also allows lighting to be turned on, once electrical systems are confirmed to be safe. Work continues in parallel with power companies on restoration of AC Mains supply.

6. **Planning.** Network engineers are engaged to plan the short- and longer-term restoration of services. Planners work to achieve two goals: Firstly, to restore customer services; and secondly, to develop a more flood-proof solution, to minimise the possibility of future floods causing the same level of service disruption. In the case of Lismore Exchange, the plan included relocating some transmission equipment to the second floor, as well as upgrading it to higher capacity to accommodate future bandwidth growth in the region.

7. **Implementation.** Once the plans are developed and approved, work commences to deploy new equipment. Material and equipment are ordered, shipped and installed. In the case of Lismore Exchange, technicians skilled in different technologies worked in parallel. While some technicians rebuilt transmission infrastructure on the second floor, Optic Fibre technicians worked on fibre repairs.

8. **Customer migration.** Finally, customers are migrated to the new equipment and services are restored. In the case of Lismore exchange, it was our backhaul transmission that was impacted. At the date of writing this submission, the majority of customers had been migrated onto a permanent backhaul solution, however, a small subset of customers are still being served by a temporary backhaul solution that involved rebuilding parts of the water-damaged transmission service. We plan to migrate these customers to a permanent solution once the transmission upgrades (see step 6 above) are complete.

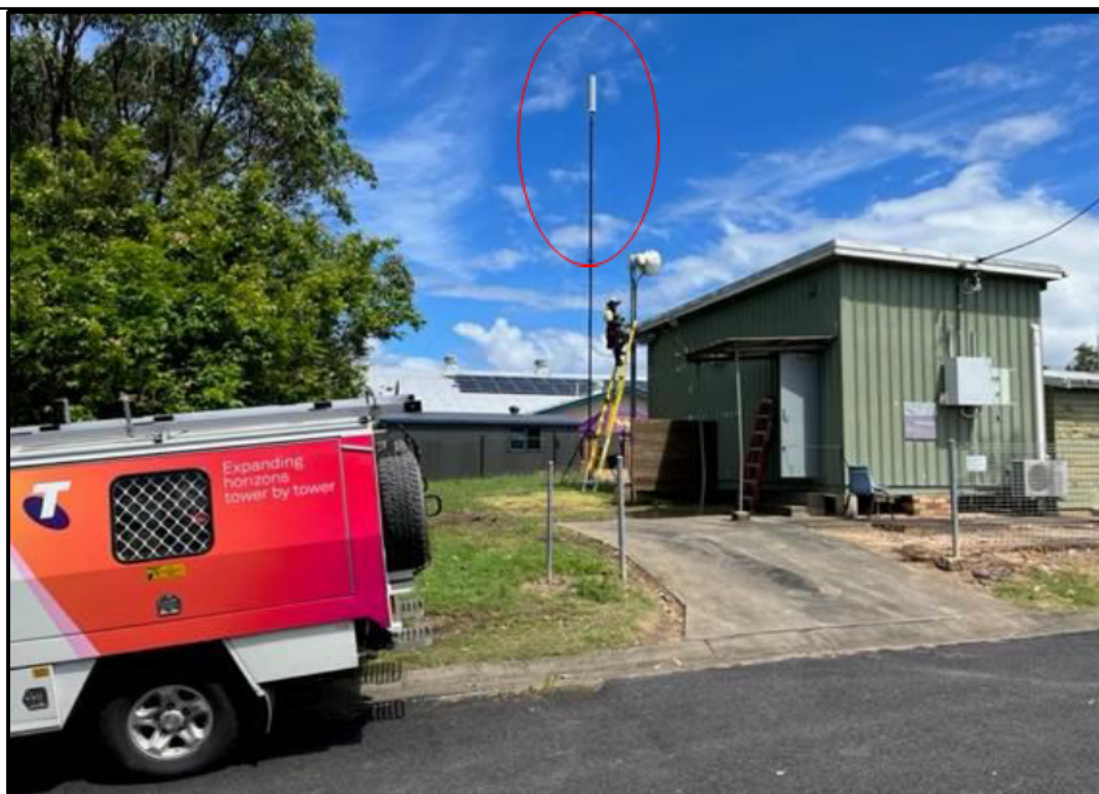
This loss of mobile coverage resulted in significant communications loss for the Woodburn community, which was overcome by deploying a COW at the back of the Woodburn exchange, as shown in Figure 8

Figure 8: View of the Woodburn Exchange with the antenna of the COW visible behind the exchange building (red circle).

This reinstated mobile coverage on 12 March. This temporary mobile solution will stay in place for several months to allow the original mobile site at Buckendoon to be rebuilt. We note Woodburn was declared a community in isolation from 2 March to 8 March inclusive as PSTN services were also disrupted during this time. Once PSTN services were restored on 8 March, the community in isolation status was removed.
